Small Earth Dam Failures in the Lomnice River Basin

Ing. Jan Jandora, Ph.D.

The catastrophic flood in August 2002 that attacked a part of the Czech Republic, Austria and Germany, caused breaks of more than 70 ponds in the Czech Republic. The paper is dealing with the analysis of breach of small earth dams located in the south of the Czech Republic in the Lomnice river basin.

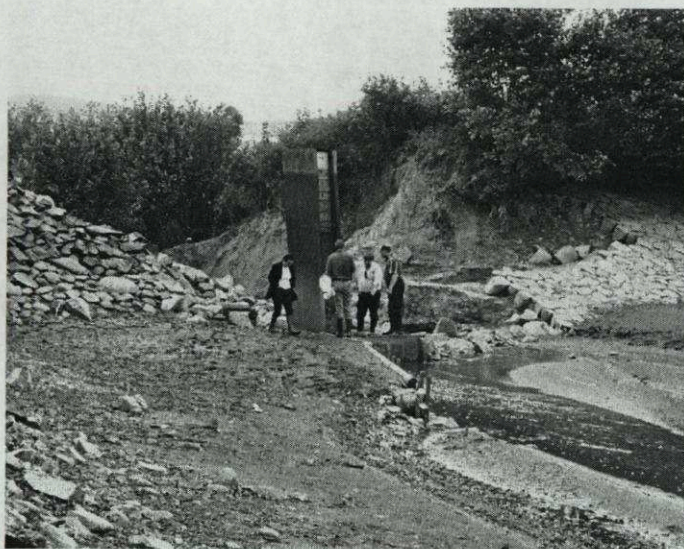
Figure 2: View of the Melin dam breach

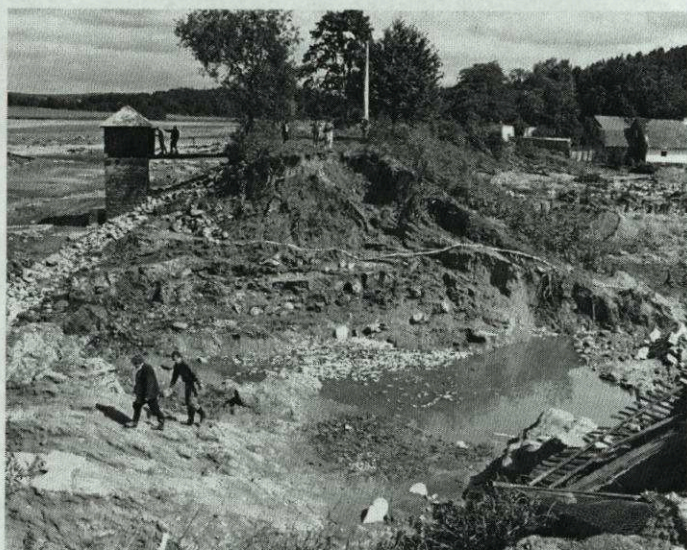
Figure 3: One of the two dam breaches of the Metelsky dam

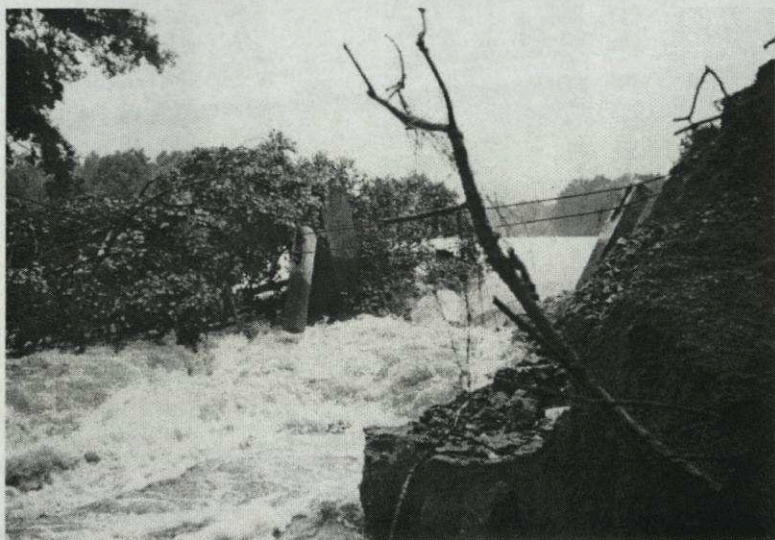
Figure 4: Flow through the Luh dam breach

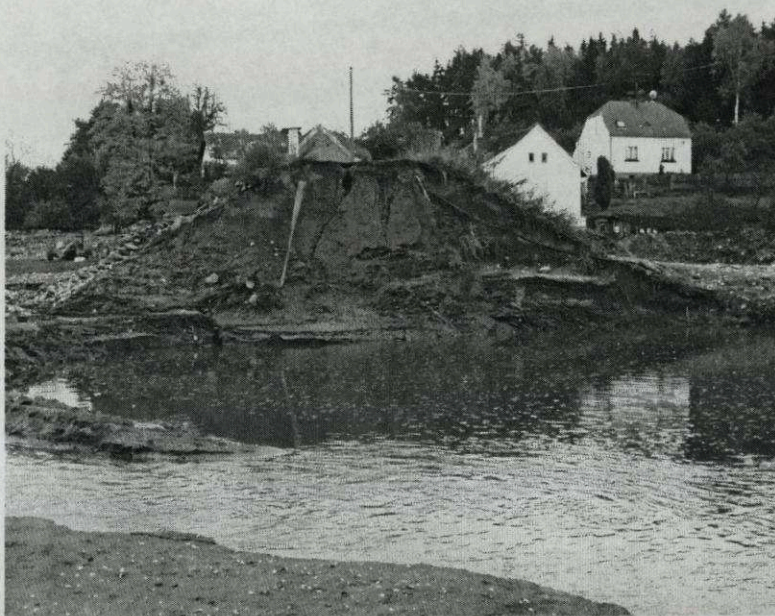
Figure 5: The Velky Belcicky dam breach

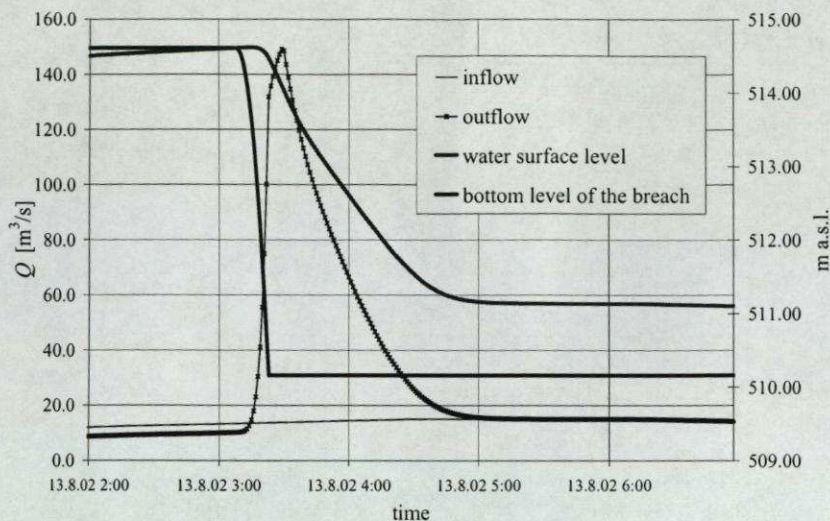
Figure 6: Hydrographs of inflow and outflow, water surface level and bottom level of the breach of the Melin dam

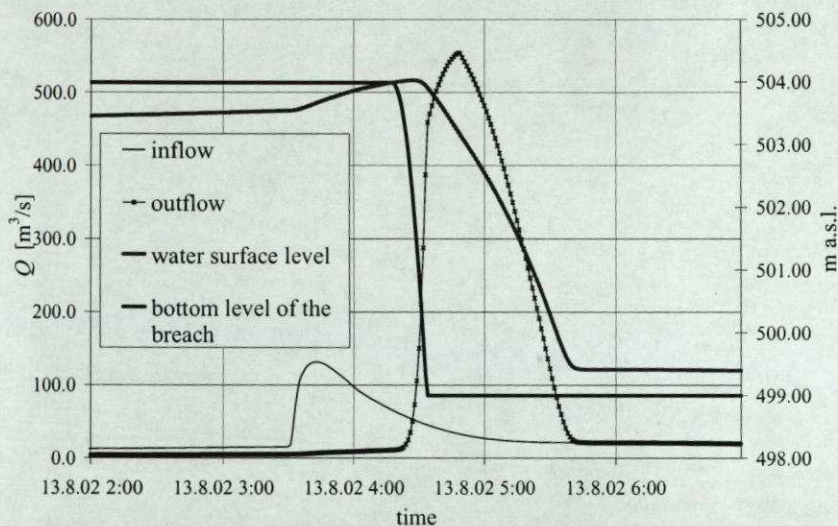
Figure 7: Hydrographs of inflow and outflow, water surface level and bottom level of the breach of the Metelsky dam

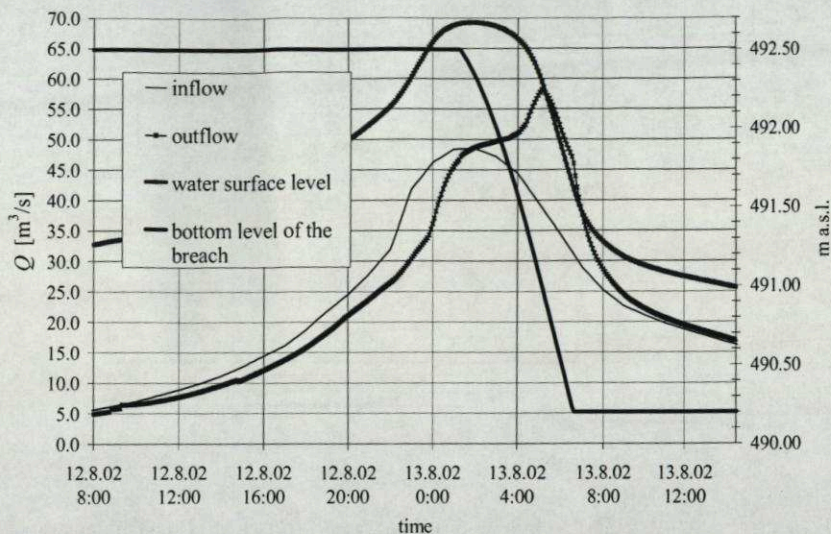
Figure 8: Hydrographs of inflow and outflow, water surface level and bottom level of the breach of the Luh dam

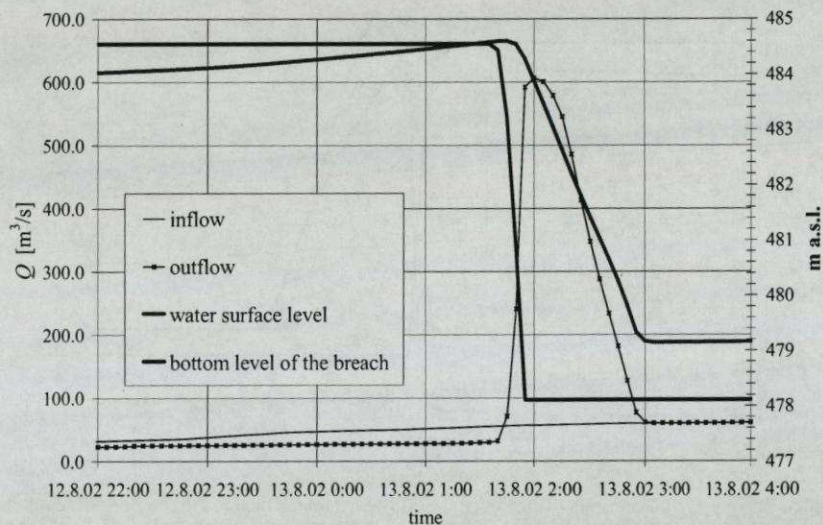
Figure 9: Hydrographs of inflow and outflow, water surface level and bottom level of the breach of the Velky Belicky dam

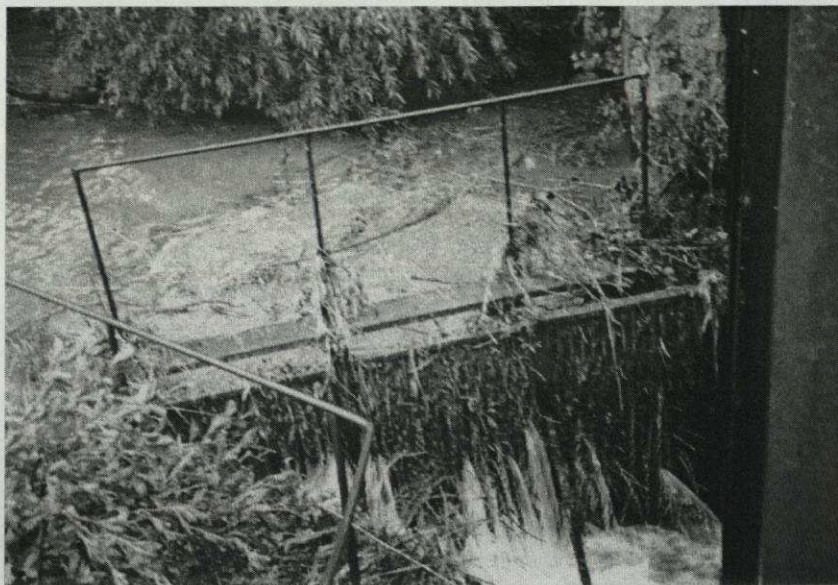
- hydrological situation;
- insufficient spillways capacity;
- in some cases the spillways were blocked by broken gates or clogged racks (Figure 10);
- malfunction of the bottom outlet;
- local slides of the downstream slope;
- action of wind driven waves;
- privileged seepage paths along the wood pipe outlets;
- breaching upstream dam or dams.

Figure 10: Spillway of the Luh dam was blocked by clogged racks during the flood
